UNIT 40

BUENA VIDA TOWNHOMES

8520 GULF BOULEVARD
NAVARRE BEACH, FLORIDA

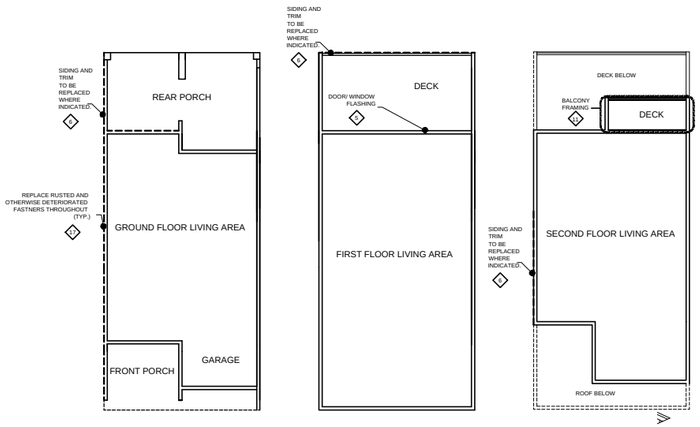
FLOOR PLAN

1. IT IS RECOMMENDED THAT ALL EXTERIOR SIDING AND TRIM BE REPLACED COMPLETELY, DUE TO THE CONDITION OF THE FASTENERS. THE FASTENERS ARE DETERIORATED AND MAY NOT BE SPACED ADEQUATELY. THE DRAWINGS INDICATE EXTERIOR SIDING AND TRIM TO BE REPLACED AS A MINIMUM. IT MAY NOT BE NECESSARY TO REPLACE SIDING THAT IS NOT ROTTED OR OTHERWISE DAMAGED IF ADDITIONAL FASTENERS ARE PROVIDED WITH THIS WORK. FASTENERS SHOULD BE PROVIDED ON ALL EXTERIOR ELEMENTS (SIDING AND TRIM) @ 6" O.C. SPACING MINIMUM.
2. ALL ROTTED OR OTHERWISE DETERIORATED SIDING, TRIM, AND FRAMING THAT IS DISCOVERED DURING THIS WORK SHALL BE REPLACED WITH EQUAL MEMBERS. ALL WOOD WILL BE PRESSURE TREATED.
3. CONTRACTOR SHALL USE COMPATIBLE GALVANIZED OR STAINLESS STEEL FASTENERS.

MARK	UNIT 40:
1	THE WALL / ROOF FLASHING IS RECOMMENDED TO BE INSTALLED PER DETAIL 1
2	THE WALL / ROOF FLASHING IS RECOMMENDED TO BE INSTALLED PER DETAIL 2.
4	THE HORIZONTAL FLASHING BETWEEN UNITS IS RECOMMENDED TO BE INSTALLED PER DETAIL 4.
5	THE HORIZONTAL FLASHING ABOVE DOOR AND WINDOW OPENINGS IS RECOMMENDED TO BE INSTALLED PER DETAIL 5
6	ANY ROTTED OR OTHERWISE DETERIORATED WOOD ENCOUNTERED IS RECOMMENDED TO BE REPLACED WITH PRESSURE TREATED WOOD OF EQUAL SIZE
11	IT IS RECOMMENDED TO REPAIR BALCONY STRUCTURES PER DETAIL 7
12	REPAIR BROKEN LOUVERS
14	REPLACE SOFFET/FASCIA
17	FASTNERS TO BE PROVIDED ON ALL EXTERIOR ELEMENTS @ 6" SPACING MIN. CONTRACTOR SHALL USE COMPATIBLE GALVANIZED OR STAINLESS STEEL FASTNERS.
